MOSSLEY

Further to our recent conversation and my site visit, I would like to submit the following report and quotation in regards to the roof area of the above property.

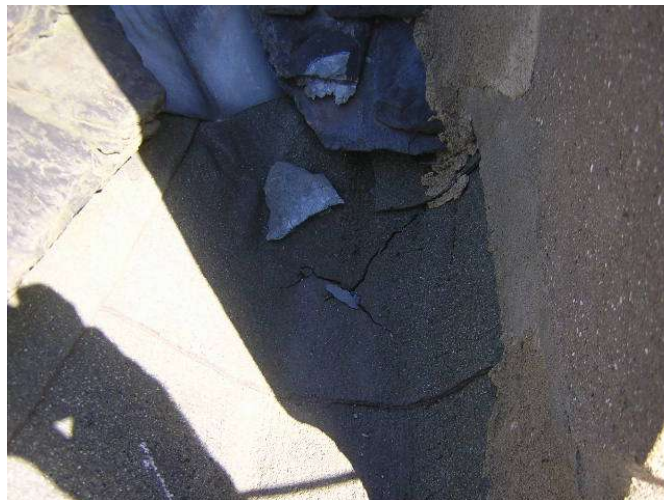
On inspection it is evident that a section of mineral felt has cracked leading to water ingress.

Defective Mineral Felt.

To carefully remove the existing defective section of mineral felt, prior to applying a torch on flashband to affected area.

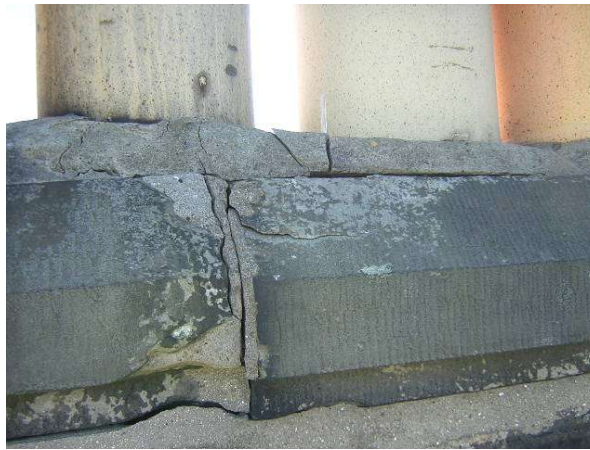
There are also a number of cracks evident in the mortar skew at the base of the chimney, which could again lead to water ingress.

The existing mortar haunching on top of the chimney has also failed and lifted from the stone cope, in a number of places.

To infill existing cracks in mortar skew with an appropriate cement based render.

To carefully remove the defective haunching to the chimney, prior to rehaunching, using an appropriate mortar.

And finally to carefully repoint the existing defective joints to the chimney using an appropriate lime based mortar.
